BUTLER STORAGE RESERVOIR DAM
WARREN COUNTY, NEW YORK

PHASE I INSPECTION REPORT
NATIONAL DAM SAFETY PROGRAM

CONVERSE WARD DAVIS DIXON
CONSULTING ENGINEERS
91 ROSELAND AVENUE, P.O. BOX 91
CALDWELL, NEW JERSEY 07006

DEPARTMENT OF THE ARMY
NEW YORK DISTRICT, CORPS OF ENGINEERS
26 FEDERAL PLAZA
NEW YORK, NEW YORK 10007

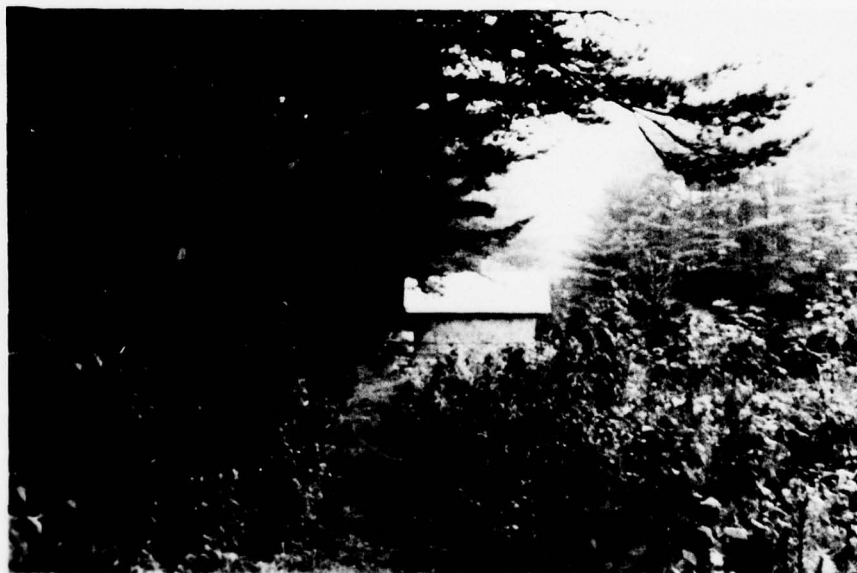
As is obvious from Figures 1 and 2, the downstream slope of the dam is heavily wooded, and supports a stand of red pine trees. The roots of these trees can be seen extending transversely across the surface of the roadway on the crest in Figure 2. Also shown in Figure 2 is the beginning of some brush and tree growth on the upstream slope. We were informed by GFWD personnel that vegetation on the upstream face was trimmed annually, although trees more than 10 feet tall were noted on the upstream face at the left abutment (Refer to Overview Photo).

FIGURE 2 ACCESS ROAD ON CREST OF DAM

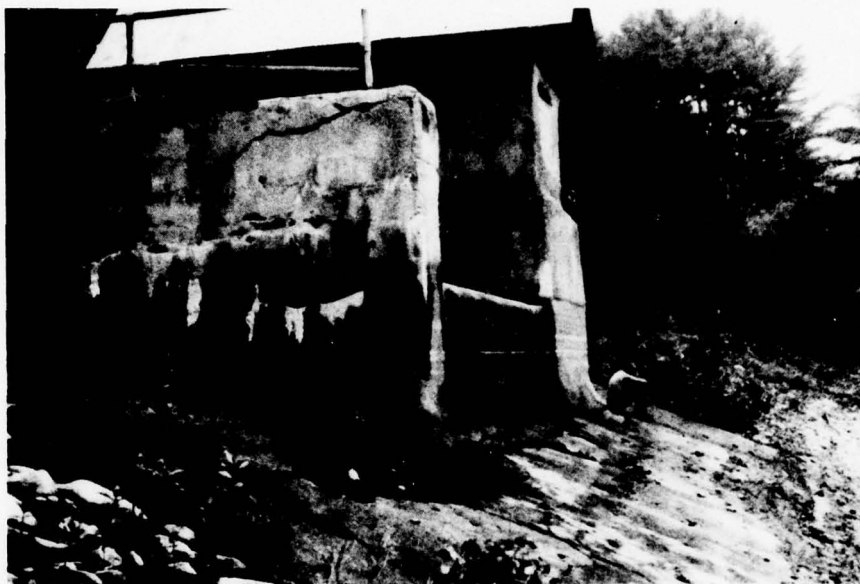
- i) There is moderate spalling and cracking of the apron, with vegetation beginning to grow in the spalls and cracks (Fig. 4, Appendix D).
- ii) The junction between the apron and the spillway/gate house superstructure is cracked with portions of previously applied gunite breaking off (Fig. 5, Appendix D).
- iii) The spillway itself appears to be in generally good condition with only minor cracking and scaling of the left pier (Fig. 4, Appendix D).

FIGURE 4 OVERFLOW SPILLWAY AND GATE HOUSE

1) The junction between the spillway/gate house superstructure and the concrete apron on the upstream slope should be repaired.

4) All other concrete appurtenances such as the concrete apron on the upstream slope should be repaired.

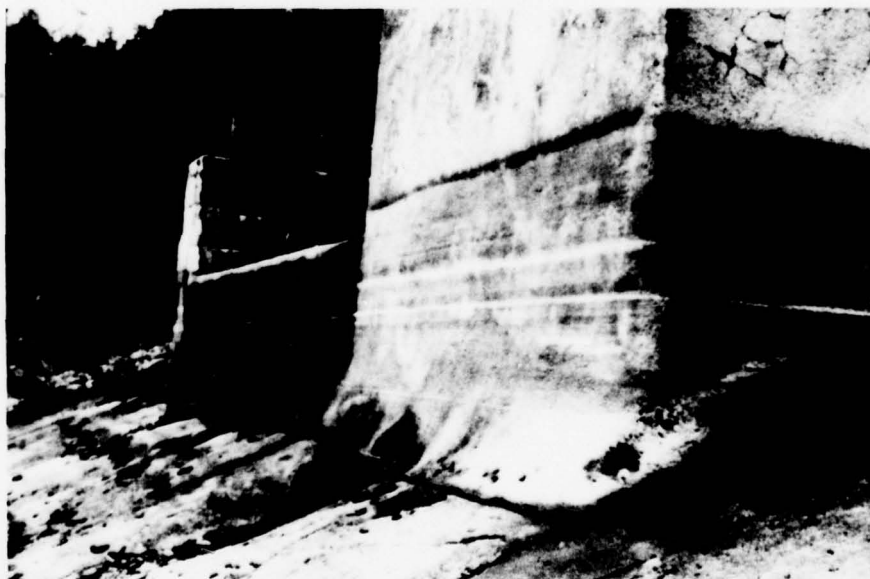
FIGURE 5 OVERFLOW SPILLWAY

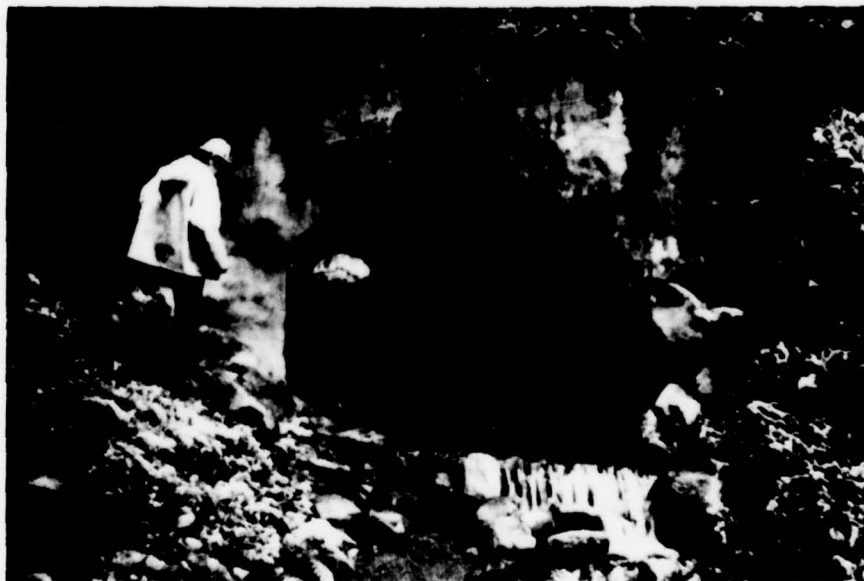
Several sections of the conduit wall and roof are severely spalled. There are many minor spalls along the length of the conduit. On the day of the inspection, there was a moderate amount of seepage coming through the larger spalls. The worst condition existed at a large spall approximately 33 feet upstream from the exit portal of the tunnel about half way up the right wall. This point is downstream of the concrete cutoff wall that runs the length of the dam beneath the crest.

FIGURE 9 EXIT PORTAL OF OUTLET TUNNEL

3) The same remedial measures as recommended for the drop inlet shaft should be applied to the outlet conduit.

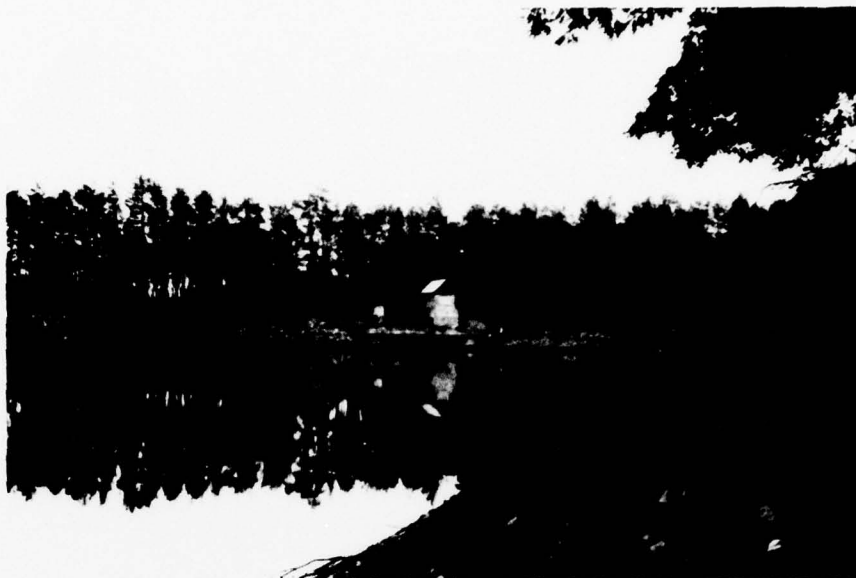
The reservoir area is heavily wooded. Slopes along the banks are approximately 3 vertical to 4 horizontal up to the high water mark (Fig. 10, Appendix D). They then increase to about 1 vertical to 1 horizontal and there is evidence of creep at the tree line (Fig. 11, Appendix D). Based on our field observations and examination of stereo pairs of air photos, there is no evidence of sloughing or sliding failures of the slopes or indications of significant siltation of the reservoir.

FIGURE 10 SLOPES ALONG RIGHT SHORELINE
